Tsunami Impacts on Shallow Groundwater and Associated Water Supply on the East Coast of Sri Lanka

A post-tsunami well recovery support initiative and
an assessment of groundwater salinity in
three areas of Batticaloa and Ampara Districts

November 2005

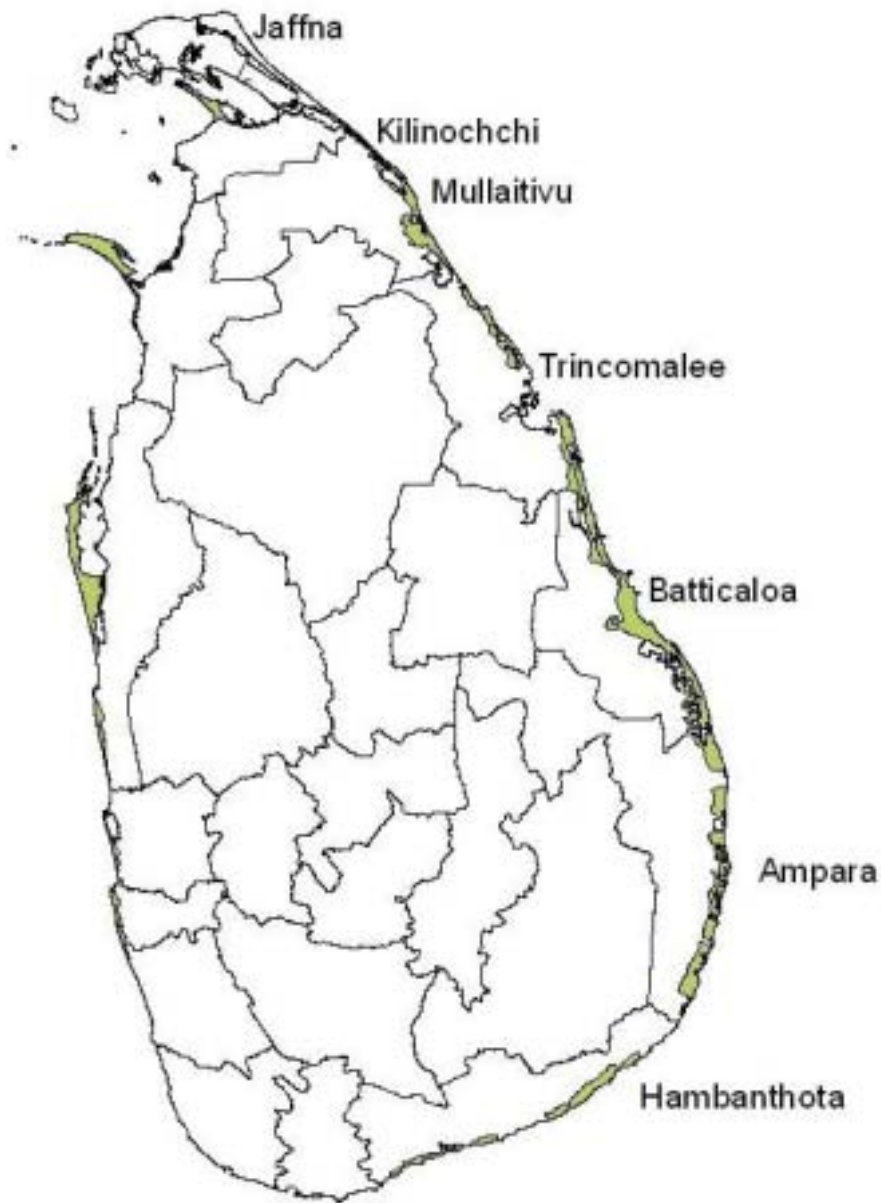
Figure 1. Extent and location of the sandy coastal aquifers in Sri Lanka

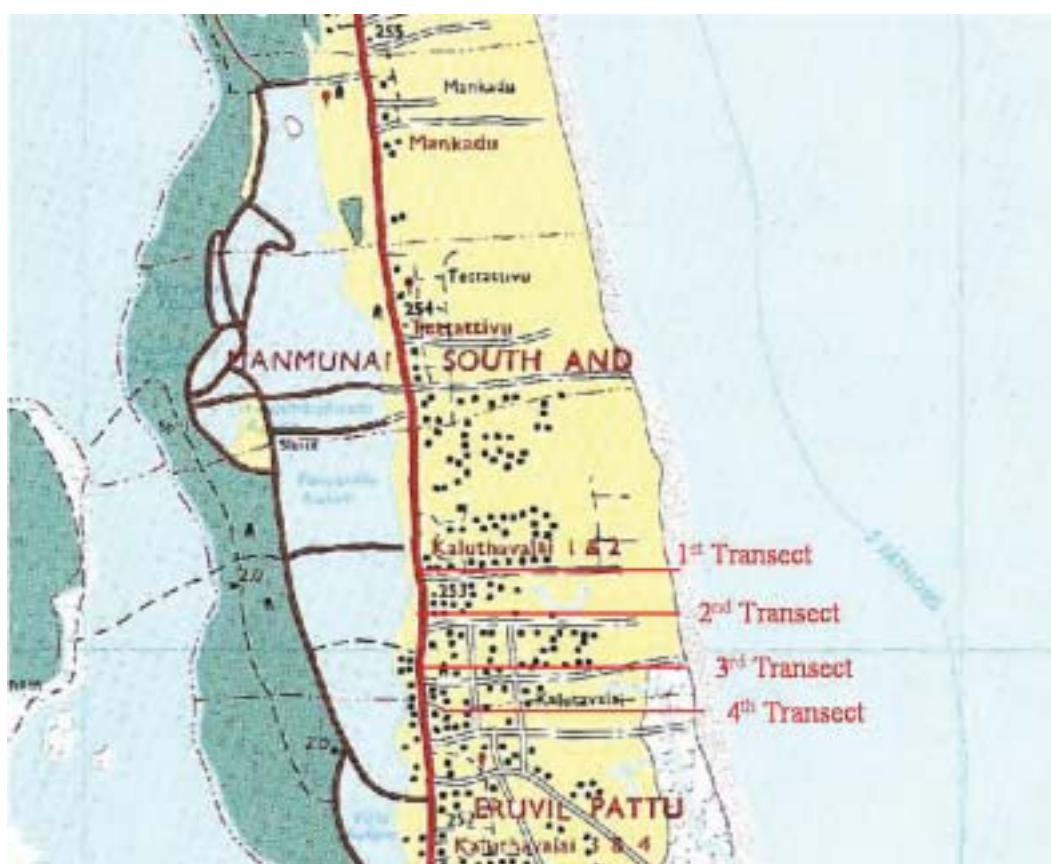
Figure 10. Sampling transects (red lines 1-4) at the Kaluthavalai site

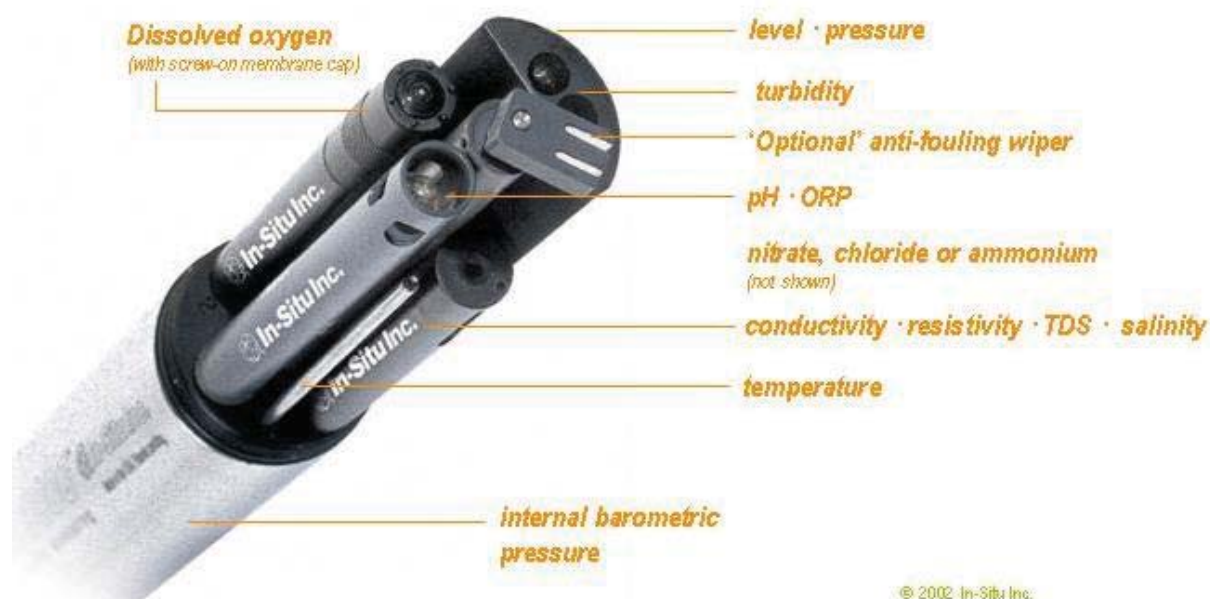
Multi-Parameter TROLL 9000

Figure 12. The Troll 9000 in-situ probe used in the monitoring program. Note that not all sensors applied in this study

Groundwater levels in the wells were monitored by a measuring tape. Salinity, temperature, and turbidity were monitored by a 4.5 cm diameter stainless steel Troll 9000 monitoring probe from In-Situ Inc.⁶ (Figure 12). Individual sensors registered the salinity (here reported as EC, specific electrical conductivity), turbidity, temperature, and the hydraulic pressure at the water level of the sampling point. The probe automatically compensated the EC measurements for temperature.

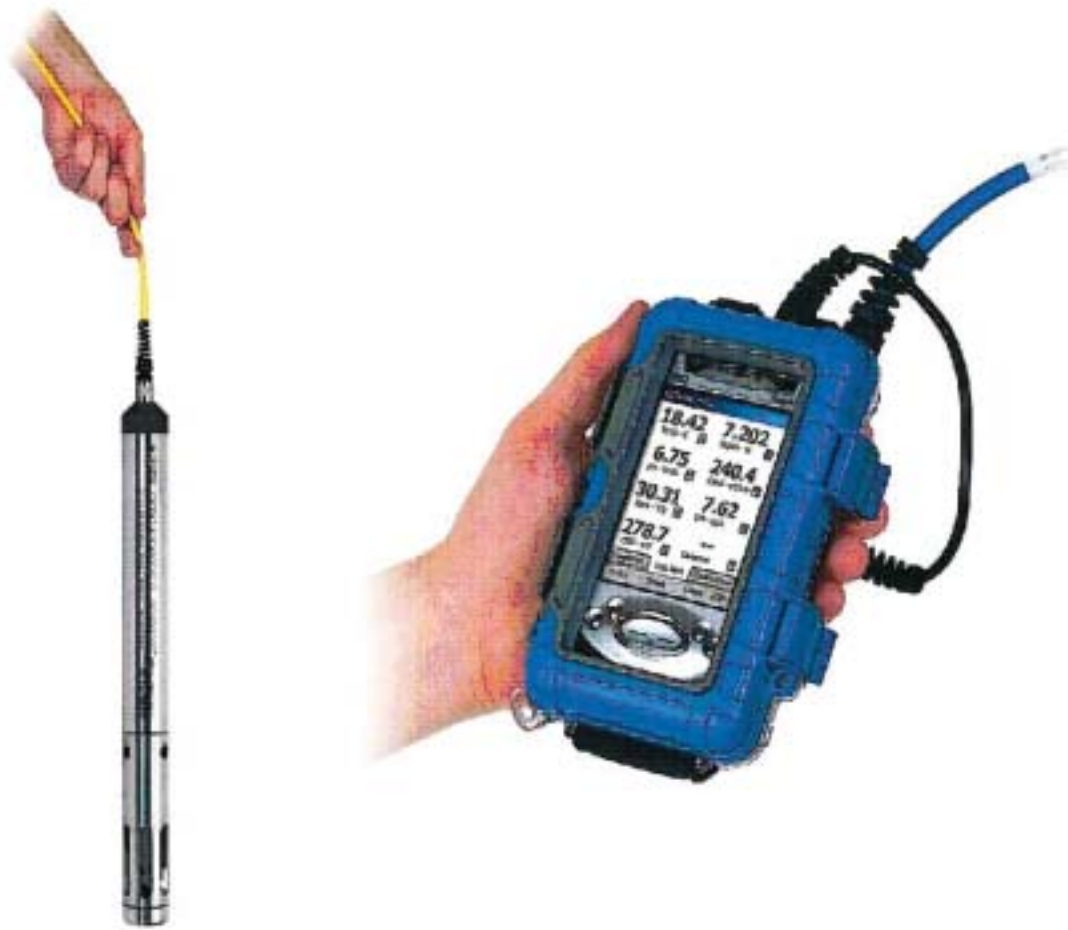
Figure 13. The Troll 9000 monitoring probe and the associated data logger

Because the probe was measuring the parameters in-situ, i.e. directly inside the well or whatever other water body, and because it was connected directly to a data logger (Figure 13), there was no need to extract samples and either measure them in the field with a portable monitoring probe or devise or to bring them to a laboratory for analysis. Also, the monitoring of salinity at different depths of a well could easily be achieved by sinking in the probe to the various levels and logging the results directly.

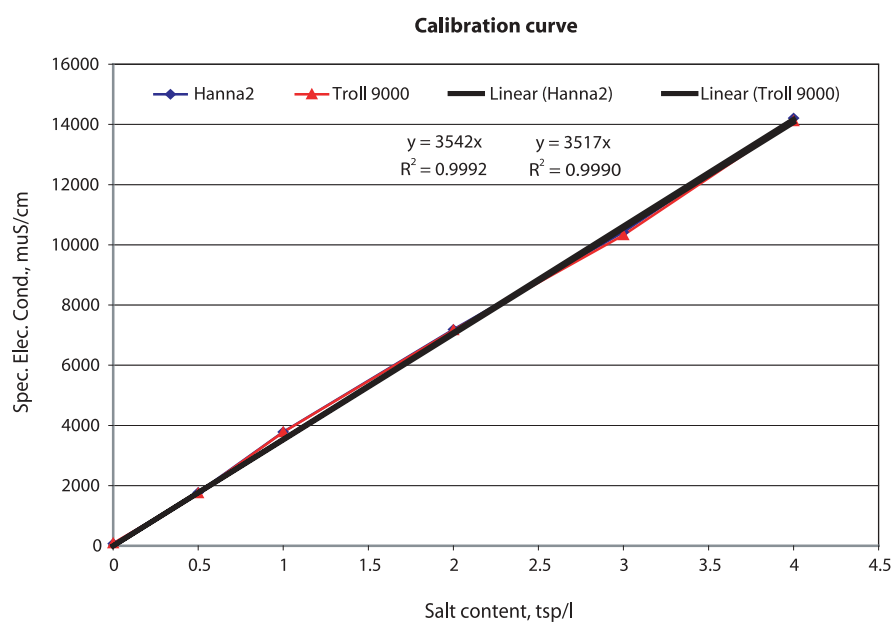
Figure 14. Calibration curve for the Troll 9000

Prior to the field trips, and to test the accuracy of the Troll probe, it was calibrated with a standard solution supplied with the instrument. Furthermore, it was tested using a standard addition principle with regular kitchen salt against the concurrent measurement with a handheld conductivity meter. The agreement between the two measurements was satisfactory and the EC was linearly correlated with salt content up to a level of 14.000 $\mu\text{S}/\text{cm}$, with an intercept of (0,0) (Figure 14).

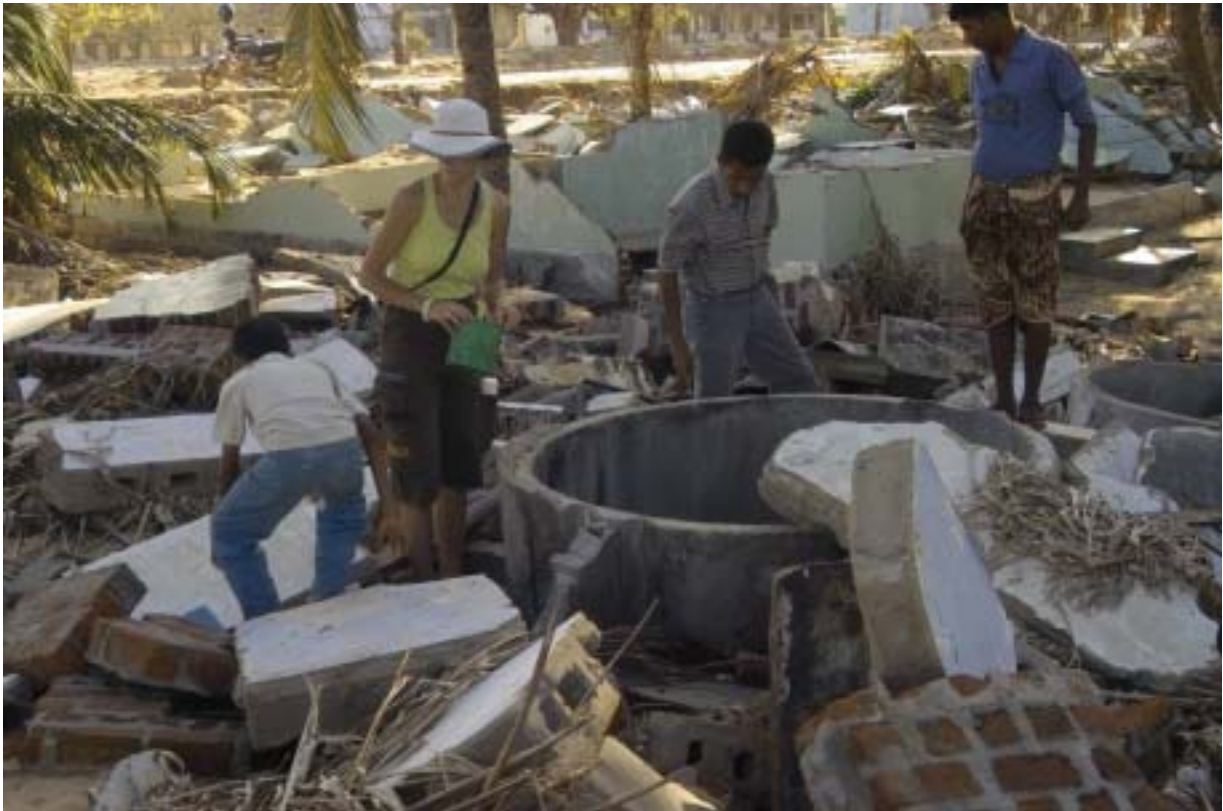
Figure 15. Initial well salinity monitoring in Maruthumunai, end of January, 2005

Table 6 shows the salinity of the wells (not properly geo-referenced) that were located at increasing distance from the coast line (Photos in Figure 15 and Figure 16 were taken during the sampling). The wells were between 3 and 5 m deep and the groundwater level at this point was 1.5 to 2 m below ground level. The data shows that the wells were very saline, but the salinity was (with one exception) significantly higher at the bottom than at the top, up to a factor of almost 10. The salinity levels as well as the stratification decreased with distance from the coast. The explanation for this could be that the wells close to the sea were abandoned and had not been in use since the tsunami whereas the wells more inland (last two) had been pumped causing a mixing of the well water. The two most distant wells belonged to houses that withstood the tsunami and hence their owners had tried to revive their water supply. It is however not clear whether these wells were in fact totally inundated by the waves.

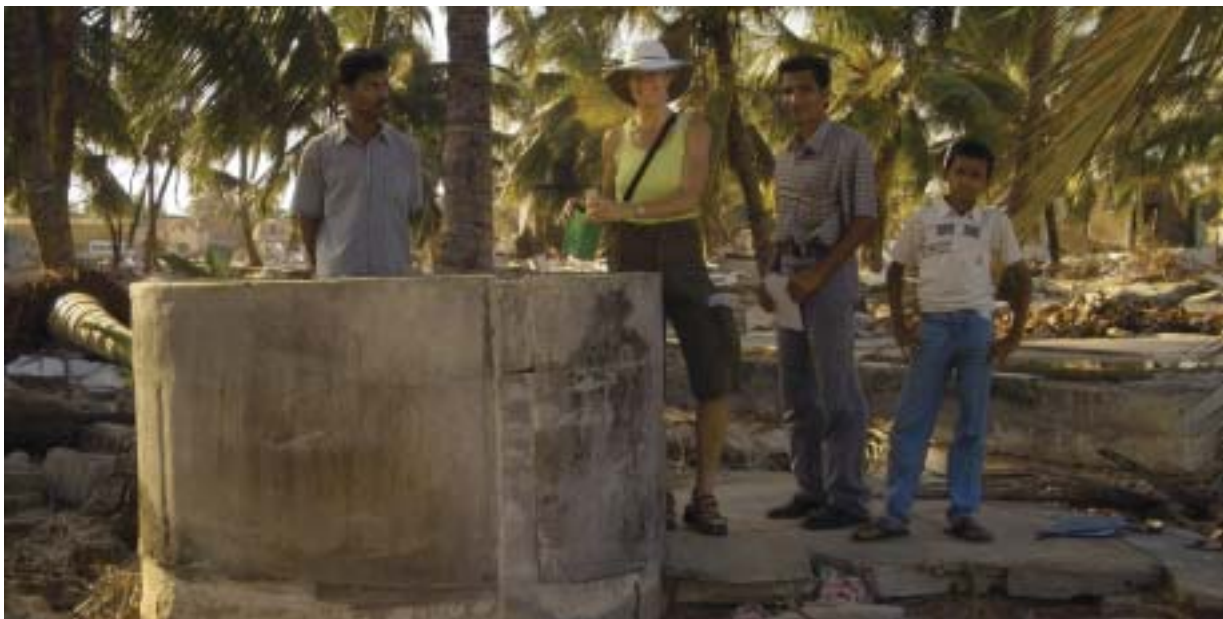
Figure 16. Well sampling very close to the coast where the tsunami eroded large volumes of coastal sand

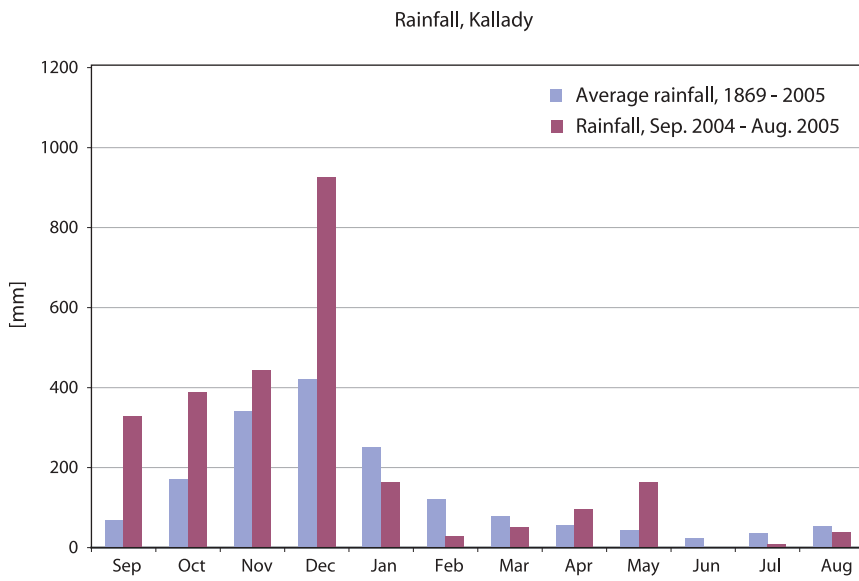
Figure 17. Rainfall in Kallady before and after the tsunami, compared to a 'normal' year

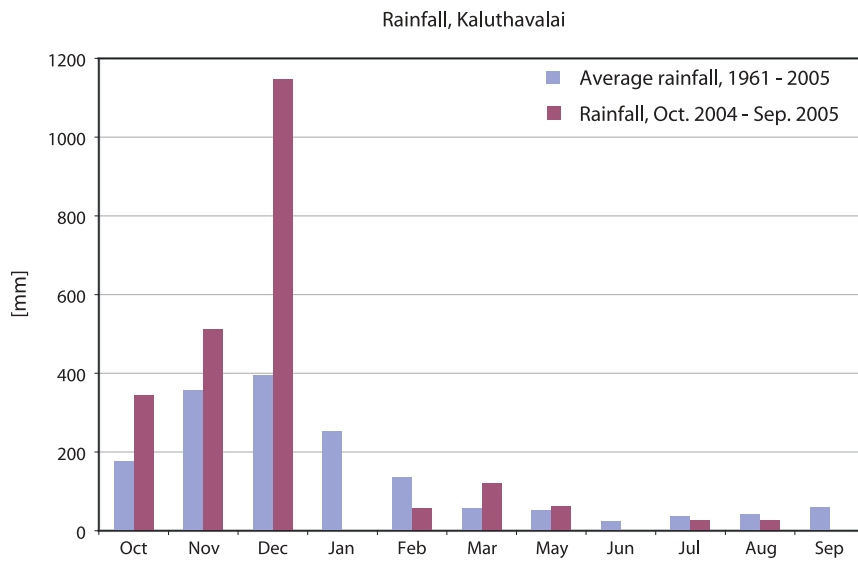
Figure 18. Rainfall in Kaluthavalai before and after the tsunami, compared to a 'normal' year

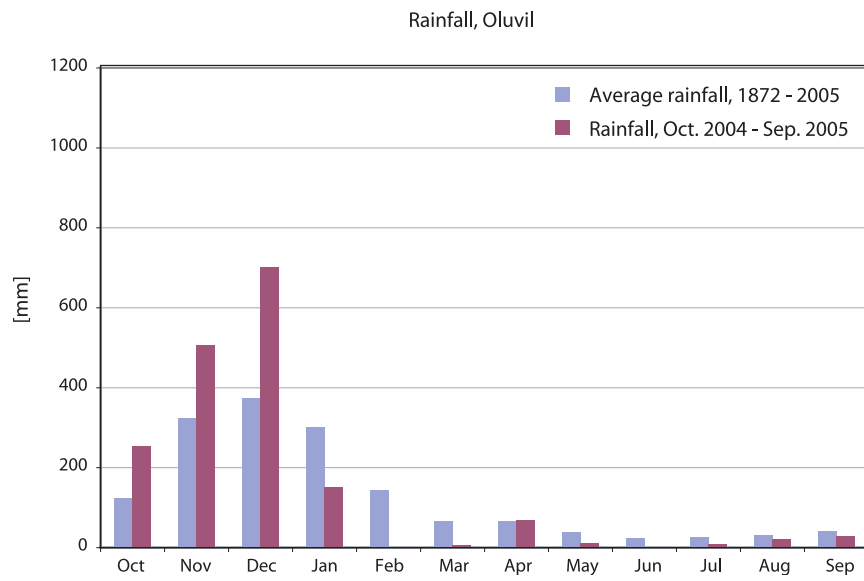
Figure 19. Rainfall in Oluvil before and after the tsunami, compared to a 'normal' year

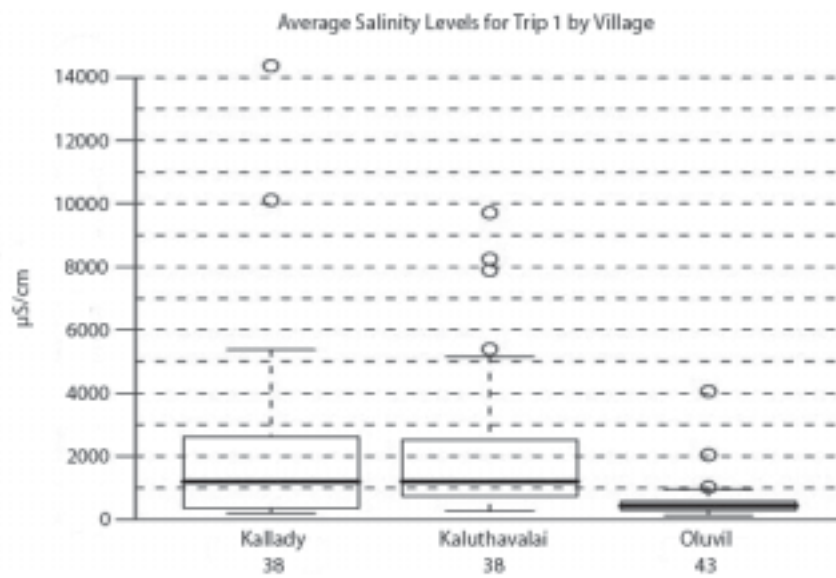
Figure 20. Average salinity levels for the three sites during field trip 1. Number of wells monitored in each site is given below village name

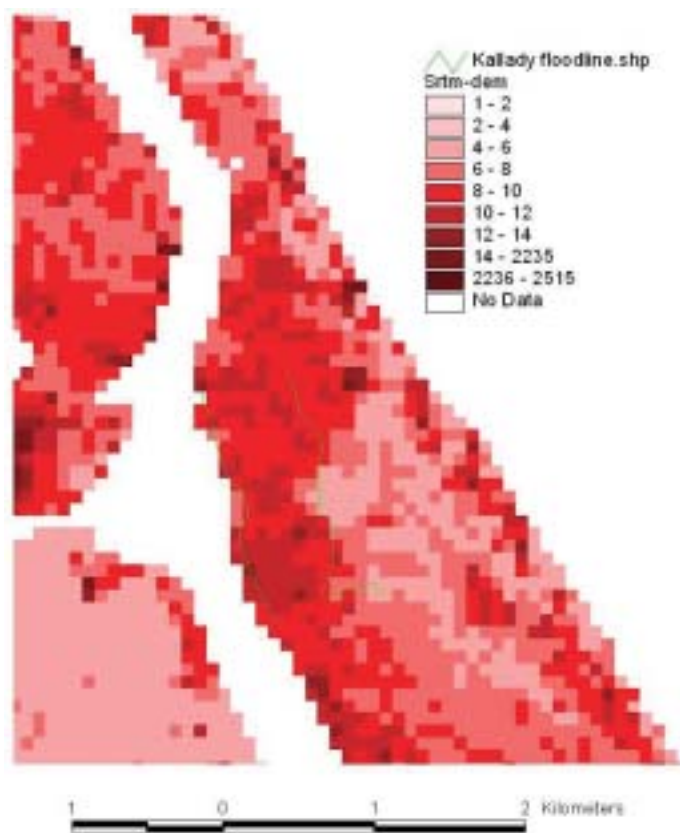
Figure 21. Topography map (SRTM-90m) with flood lines superimposed for the Kallady site

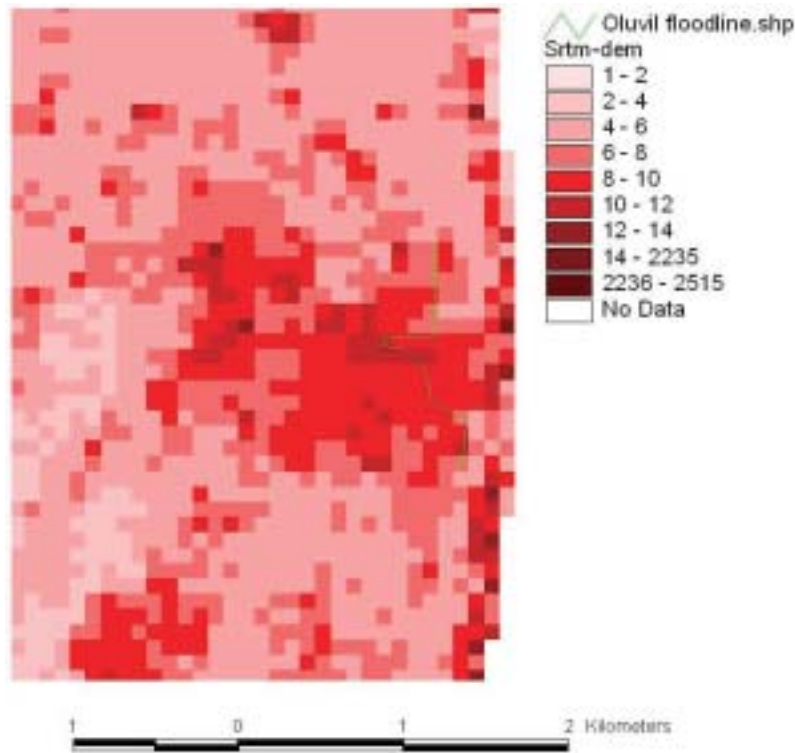
Figure 23. Topography map (SRTM-90m) with flood line superimposed for the Oluvil site

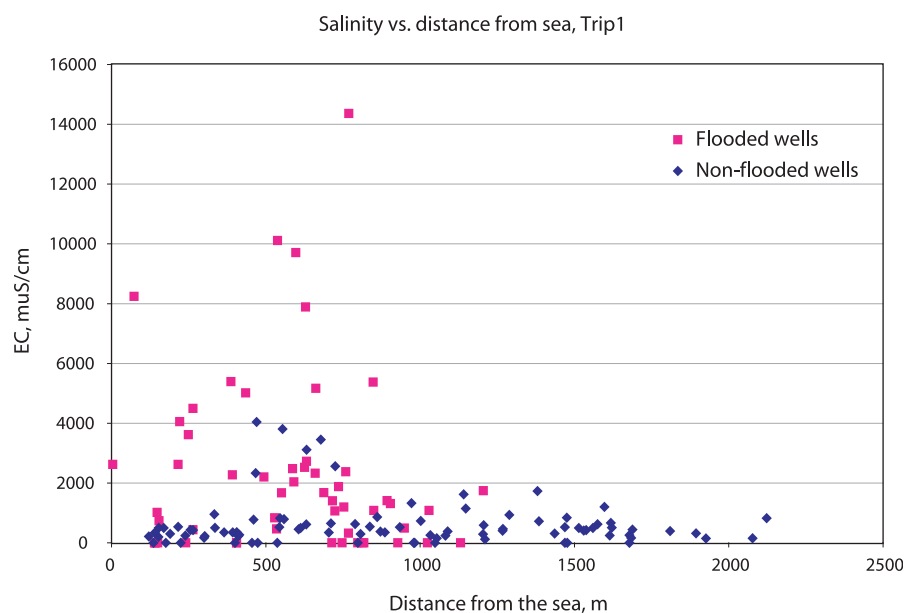
Figure 27. Salinity levels of flooded and non-flooded wells as a function of distance from the coast line during trip 1

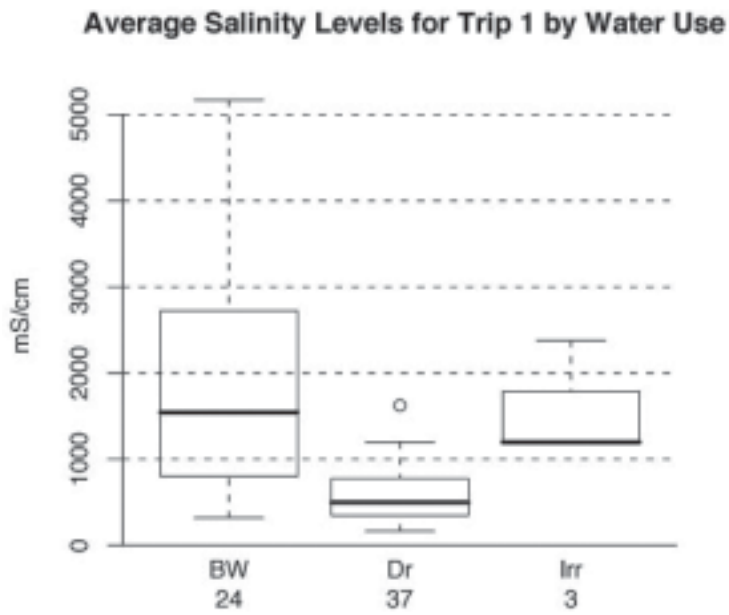
Figure 28. Average salinity levels for well water used for different purposes (BW: Bathing/Washing, Dr: Drinking, Irr: Irrigation)

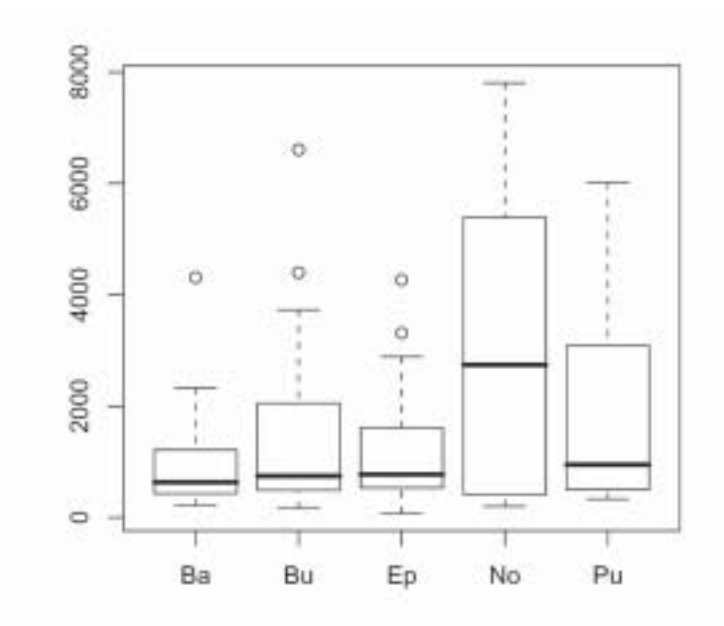
Figure 29. Average salinity for the various water extraction mechanisms on the wells (Ba: Balance, Bu: bucket, Ep: Electrical pump, No: No mechanism, Pu: Pulley)

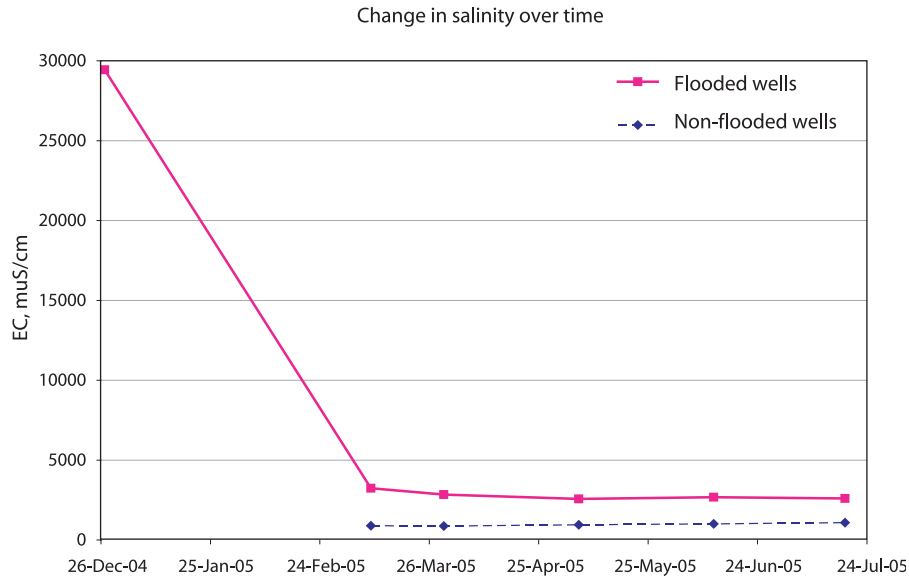
Figure 30. Average well salinity with time after the tsunami for flooded and non-flooded wells

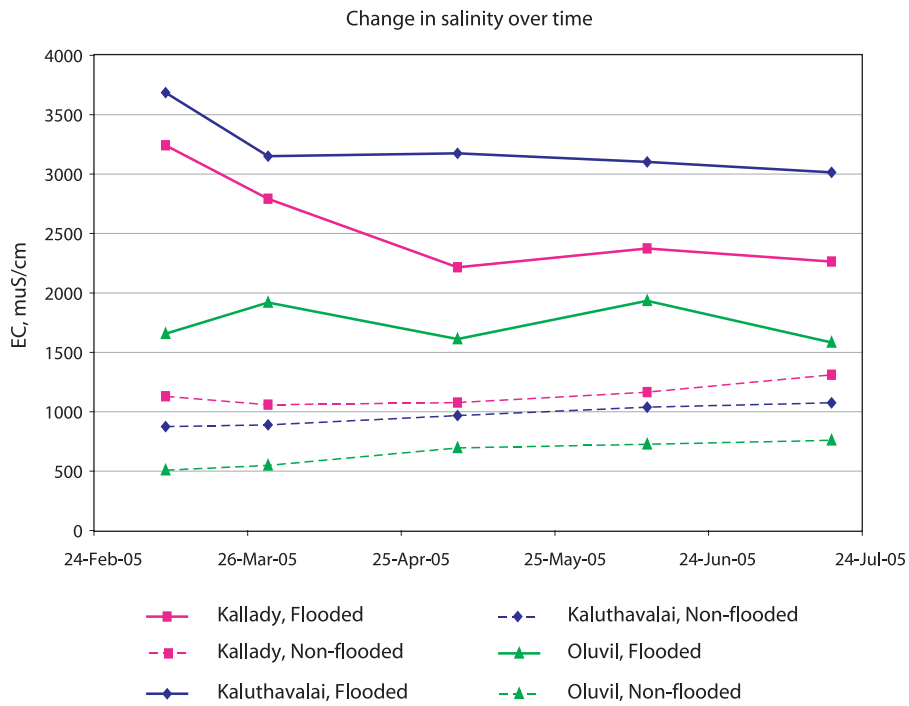
Figure 31. Average well salinity with time after the tsunami of flooded and non-flooded wells and split into the three areas

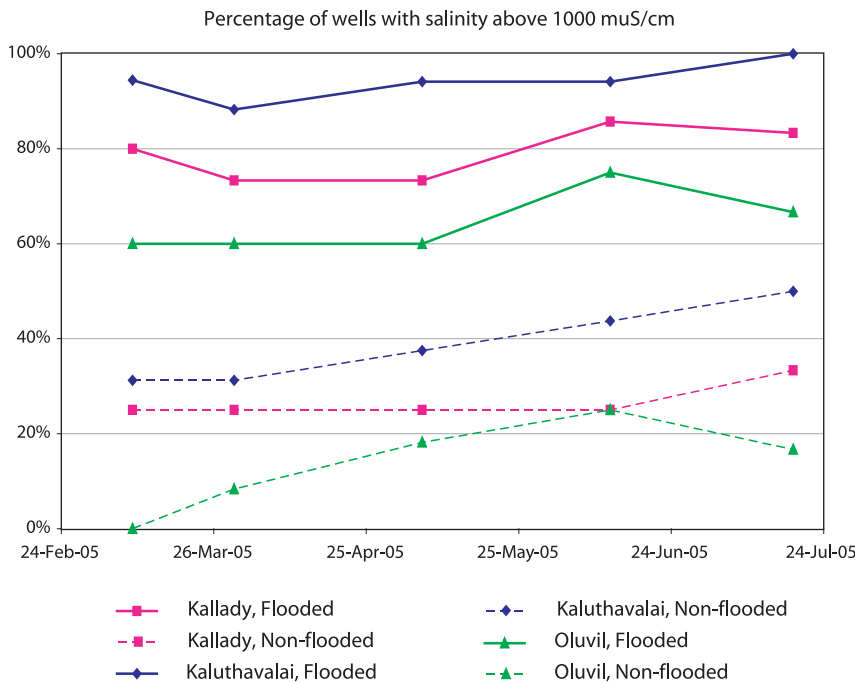
Figure 32. Percentage of wells with salinity above the drinking water thresholds a function of time after the tsunami

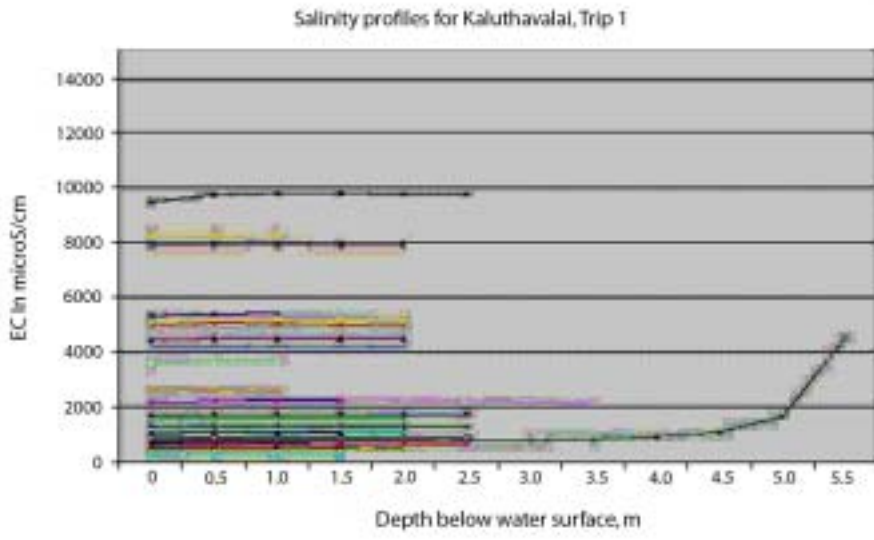
Figure 36. Salinity profiles in wells in Kaluthavalai, trip 1

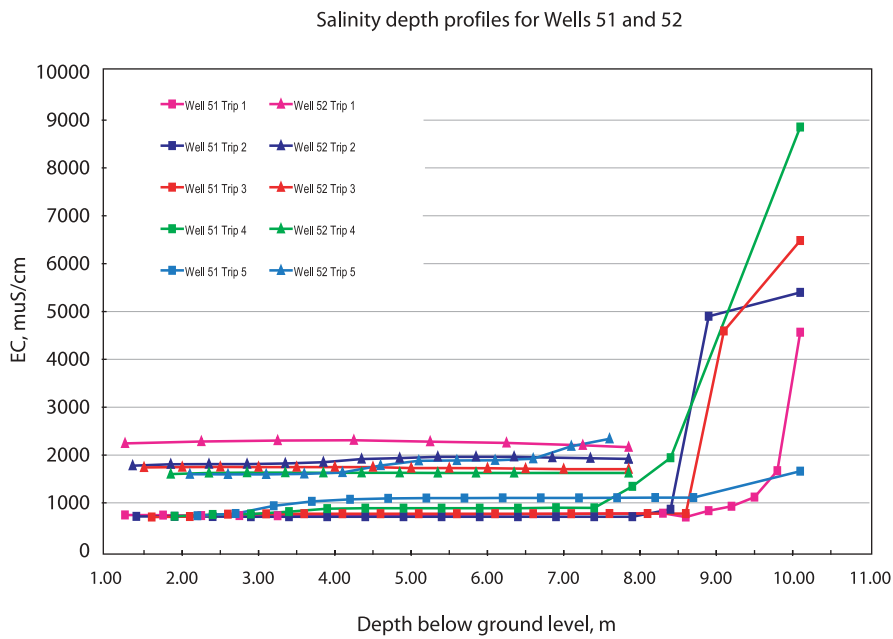
Figure 37. Salinity profiles of two wells located 50 m apart, in Kaluthavalai. Values are given for the five field trips

Constituting the only exception to the first statement in the section above, one of the wells in the monitoring program exhibited a significant increase in salinity with depth during the monitoring period, namely well 51 in Kaluthavalai, which was located 0.8 km from the coast and also was the deepest of all the monitored wells, 10.1 m (Figure 37). At approximately 8.5 m depth, the salinity increased abruptly from a steady background level of 800 $\mu\text{S}/\text{cm}$ to max. 5000 $\mu\text{S}/\text{cm}$ at the bottom.

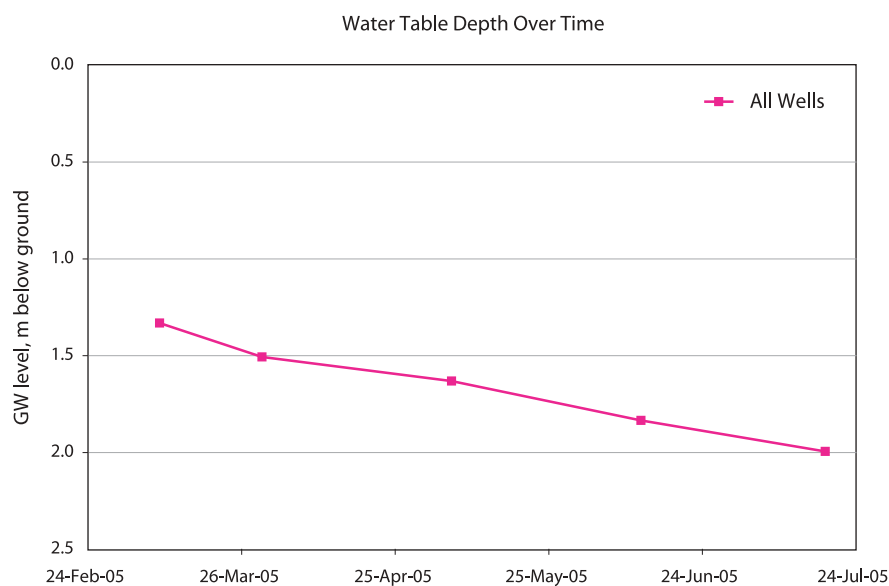
Figure 38. Drop in groundwater level during the study period for all wells

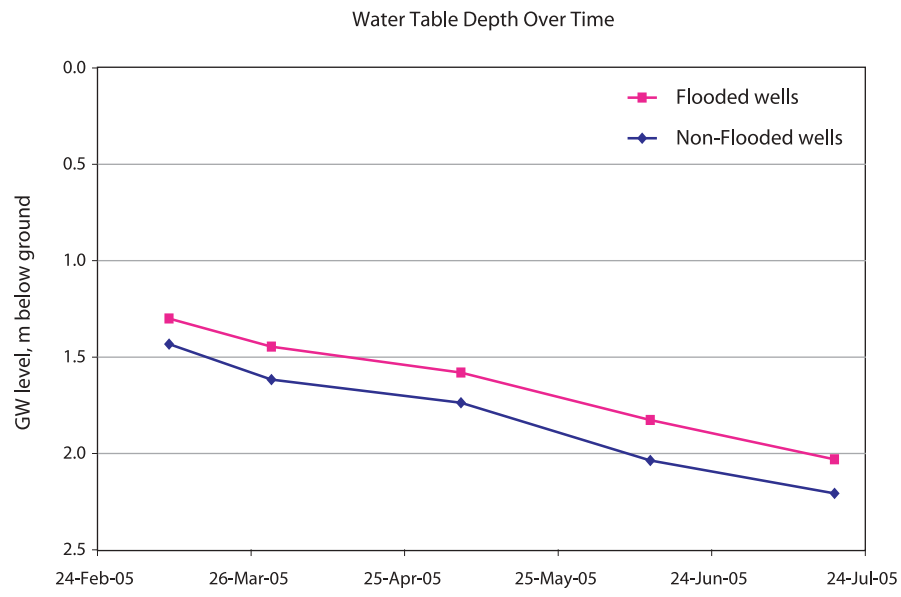
Figure 39. Drop in groundwater level during the study period for flooded and non-flooded wells

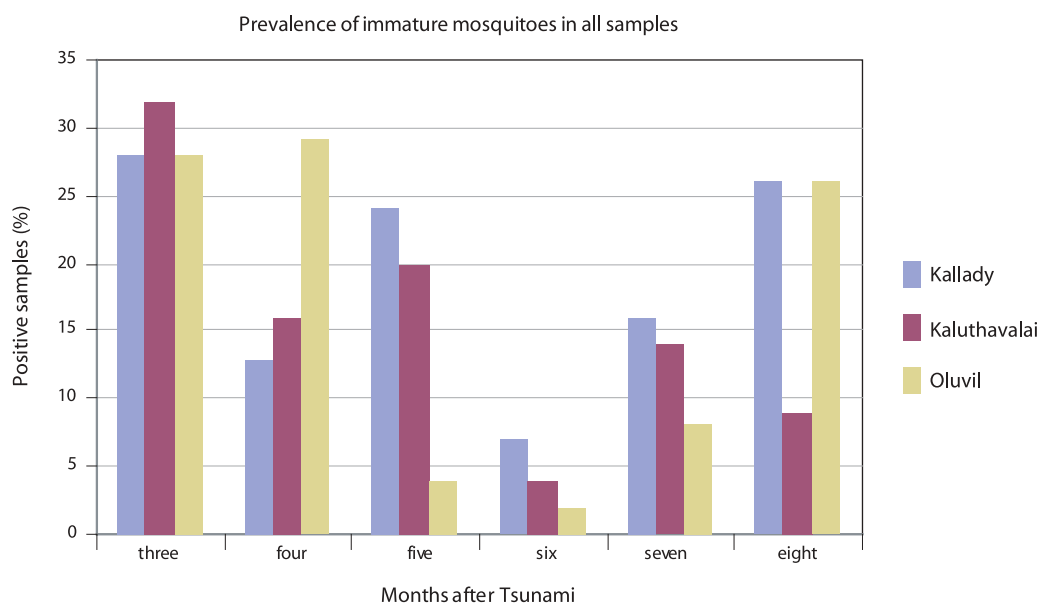
Figure 43. Prevalence of mosquito larvae and pupae in all the samples (wells, drains, rice fields, lagoons etc.)

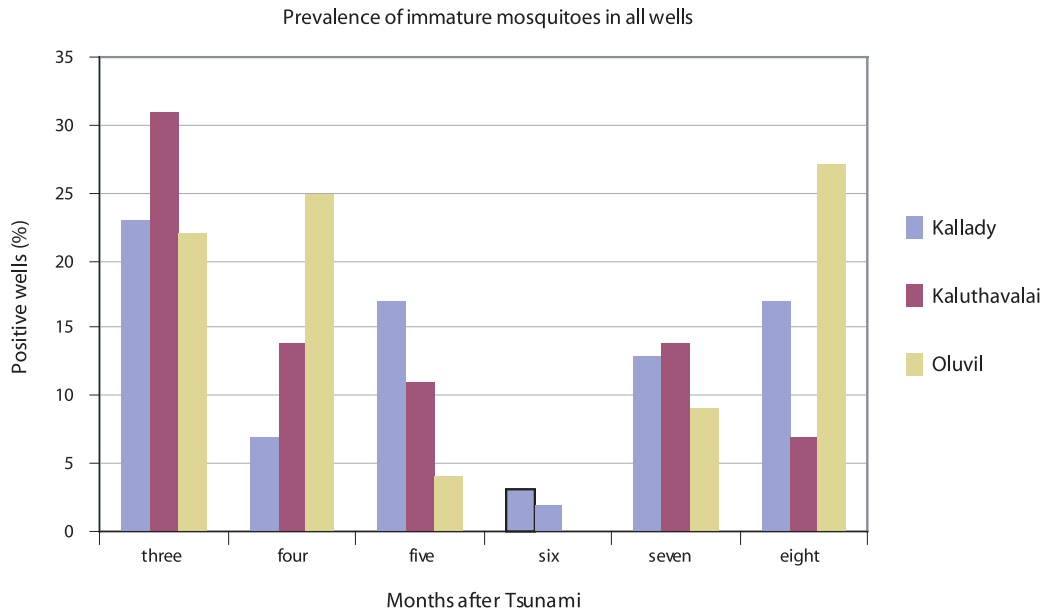
Figure 44. Prevalence of mosquito larvae and pupae in all wells (domestic wells; n =130, production wells; n=3, and agro-wells; n=3.)

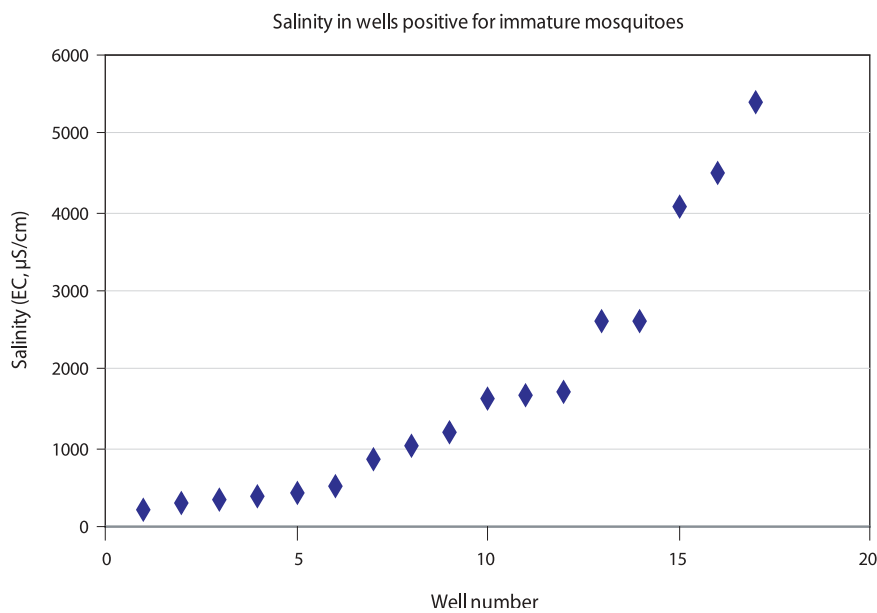
Figure 45. Salinity levels in wells that were positive for mosquitoes during the first trip (three months after the tsunami)

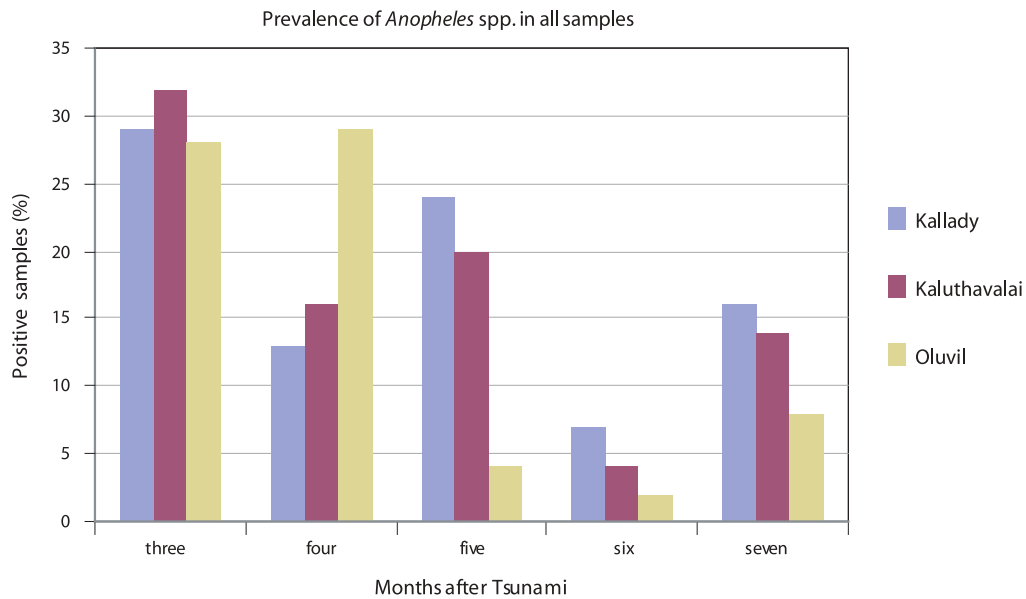
Figure 46. Prevalence of *Anopheles* spp. in all samples

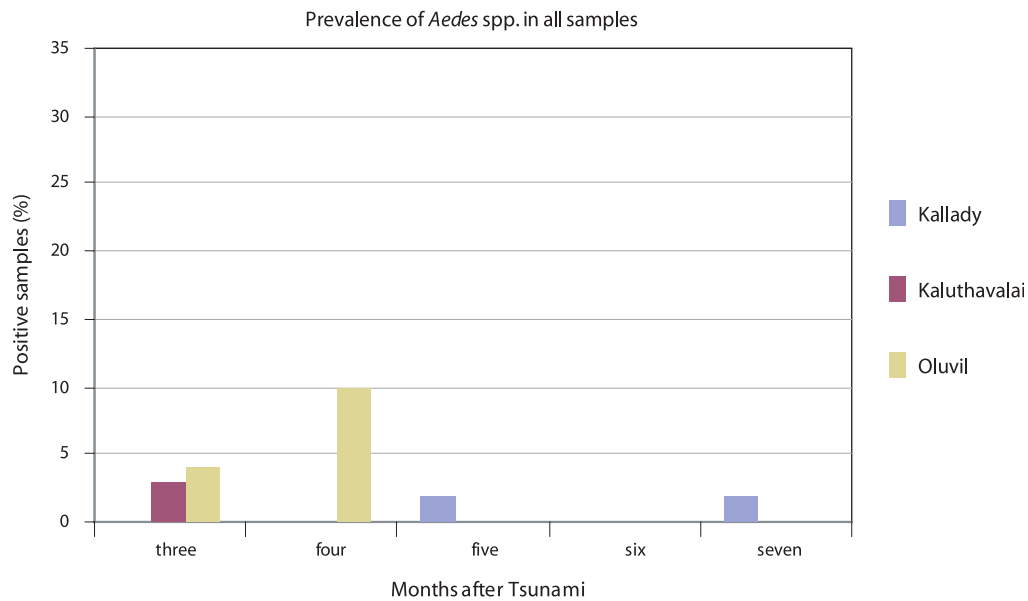
Figure 48. Prevalence of *Aedes* spp. in all samples
