**Sri Lanka Trip Report
Mark Bell & Joe Rickman
February 7-12 2005**

Objective: Review tsunami damage to paddy fields and develop recommendations for their rehabilitation.

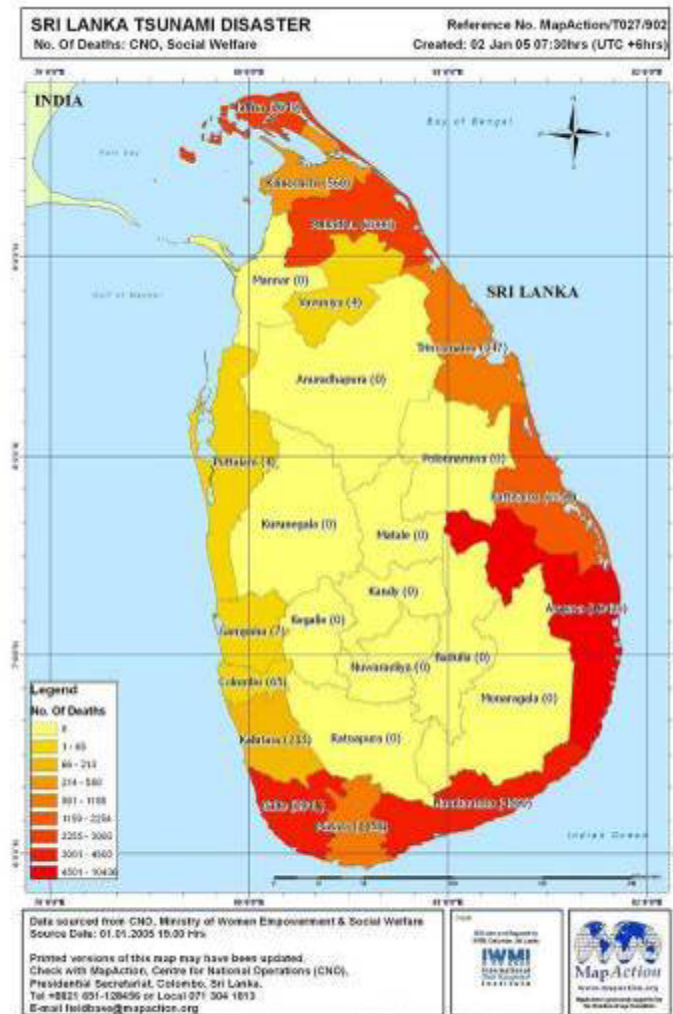
Number of Deaths: CNO Social Welfare (Source www.iwmi.org)

Staff of the Department of Agriculture (DOA) briefed us on the tsunami affected areas (See map). They detailed their initial findings on the extent of land and crops affected.

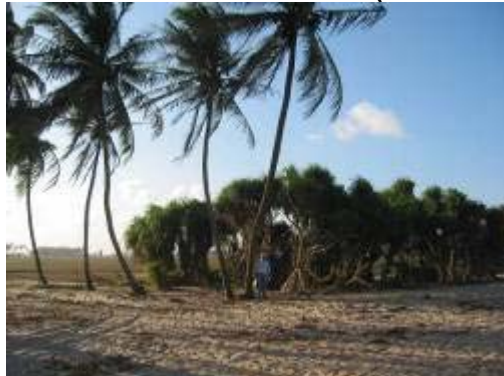
At this point of the coast, the tsunami wave topped these palm trees (around 11 m high) and spread 900 m inland. Person at base of tree shows relative height.

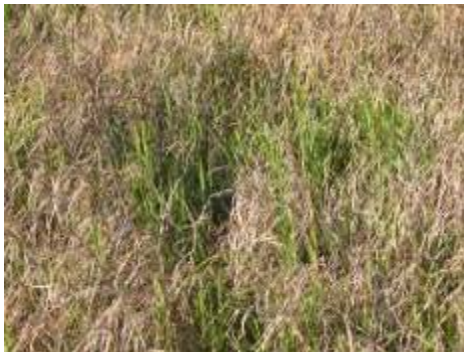
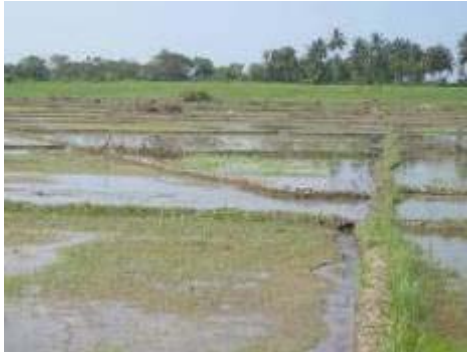
1. **Fields already in recuperation** - The majority of affected fields we saw had open drains and had received recent rainfall shortly after the salt intrusion. These fields were already showing signs of vegetative recovery (e.g., “dead” rice plants sending out new tillers and/or grass weeds growing). Many of these fields had acceptable EC readings (< 4mS/cm),

Fields that have been flushed or received rainfall and had drains open are already showing signs of recovery.

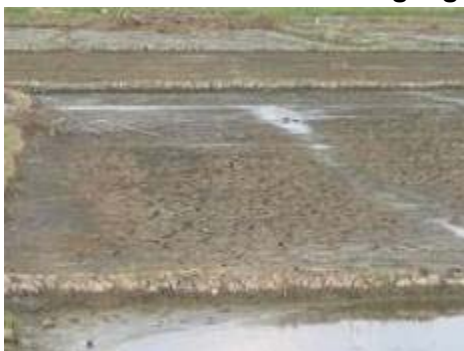
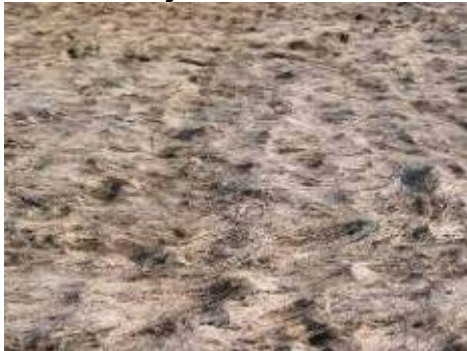
2. **Fields with serious salinity problems** - A lesser number of fields that we saw had either complete crop loss or large patches of crop death across the field. These fields were typically observed to have closed drains. The black layer reported in some fields appears to be a layer of rotting vegetative material in those fields that still have very saline surface soils. The top soils of these fields typically had very high unacceptable EC readings (> 4 mS/cm to more than 20 mS/cm) and many showed complete dispersion when placed in water (indicating high levels of Na).

- Note:** These non-flushed saline fields were obvious from the lack of vegetative growth of any form and by the presence (often) of a surface black layer (of decaying vegetative matter), and

Fields that did not have drains open continue to have high levels of salinity and no signs of plant growth.

1. **Drainage** - Clean drains and drainage canals
2. **Salt flushing** – Flush fields (not yet flushed) prior to cultivation. Fill fields with good water and allow them to stand before draining.

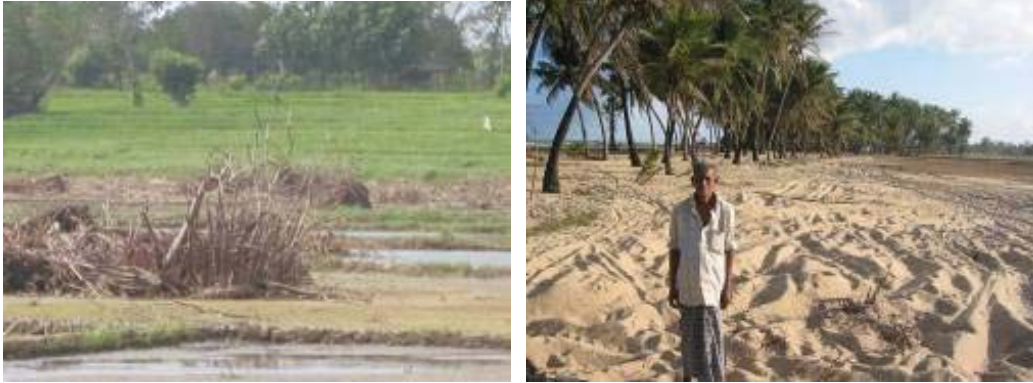
3. **Fields with sand deposits/debris** - A small number of fields close to the shore had serious problems of sand deposition on top of the existing fields.

Debris (left) in many and sand in fields close to the ocean (right) were left in farmers rice fields.

3. **Stubble** - Don't burn crop stubble
4. **Debris** – Burn or remove debris – but not the stubble.
5. **Use of rice husks** - Incorporate (if available) un-burnt rice husks during land preparation (either during or after the first plowing)

10. **EC meters** – Provide EC meters for field monitoring of affected fields. These could be placed with staff of the Agrarian Service Centers.
11. **Sand deposits** – In the few fields with sand deposits, level the deposits and manage as above.

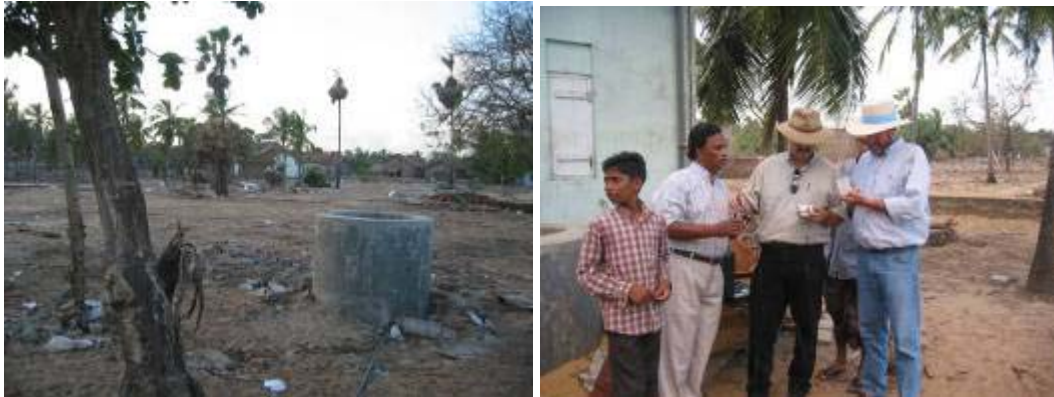
It appears that the primary cause of the salinity problems in wells is from the surface entry of saltwater. Of the wells tested, all wells filled by the tsunami wave still exhibited serious problems of salinity (>4 mS/cm). One well that had had greater use, had lower levels. There was somewhat conflicting evidence on the effect of pumping. One pumped well had higher levels of salinity than the surrounding non-pumped wells.

We suspect the affected wells have a salt water “bubble” around their intake area caused by surface pressure from the wave. The report by Karen Villhloth of IWMI helped explain the situation. She found a salt gradient in wells having received rainfall. Thus it seems likely that many of the “pumped” wells were likely only partially pumped from the top – leaving the more saline water at the base of the well.

Wells in many areas such as this well in a village devastated area (left) were filled with seawater from above. They need to be fully pumped and monitored for EC (right) until suitable for drinking and/or irrigation.

1. **Pumping** – Given the present uncertainty of the well situation, we suggest that initially a couple of tube wells that had been contaminated by seawater be pumped and have the EC monitored for a number of hours. The reason for this is that tube wells will be quicker to pump and evaluate. A submersible pump (rather than the more common centrifugal pump) is preferred in the open wells as it is capable of pumping from greater depths (> 5m). Unless lowered down the well, centrifugal pumps can only draw from approximately 5-6 m depth.

2. **Well cleaning** – If the above is found to reduce EC levels, then pump the open wells for 6-8 hours (or if EC meters are available) until the EC drops below 2 mS/cm. Many people active in well rehabilitation were recommending the addition of chlorine (2-4 l/well) to reduce the possibility of bacterial infection.

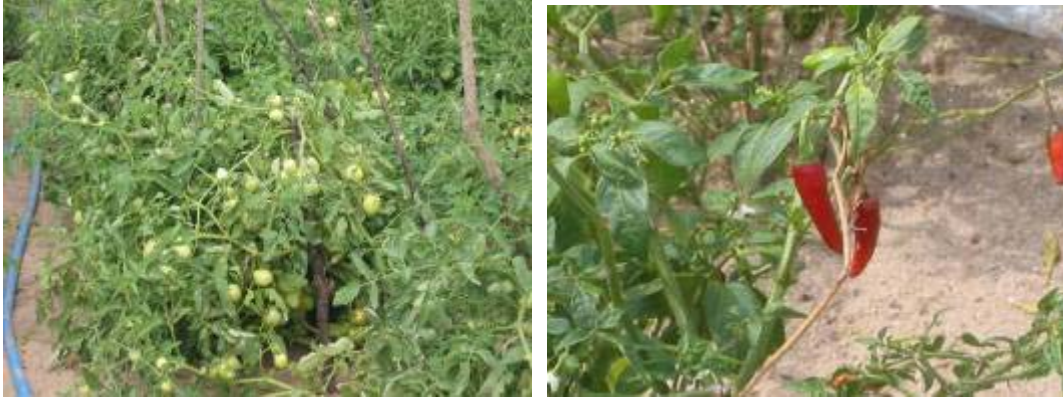
Upland crops in affected areas need clean water supplies and can be grown on beds to reduce the effects of salinity.

1. **Water sources (local options)** - If non-saline irrigation water is available, then legume and other income generating crops can be grown.
2. **Bed farming (local options)** – bed farming will help the salt affected areas.
3. **Pulse crops** – A national pulse crop strategy could be developed to ensure protein needs are met over the short to medium term.
4. **Fact sheets** – Develop fact sheets on farming alternatives and provide through the Agrarian Service Centers

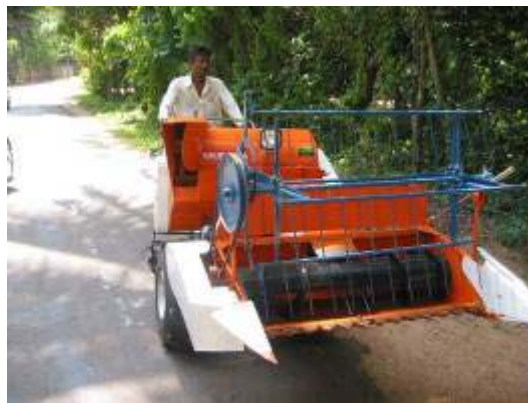
We had a number of reports of labor shortages especially for harvesting. Harvesting was being increasingly done by small combines imported from India, China and Japan. During the trip, 150 memmoties (hand hoes) were donated to farmers affected by the tsunami. Some of those interviewed indicated the problem arose from direct losses of laborers and some highlighted that refugees collected food and money when located in the refugee camp. Some felt that this may have encouraged at least a portion of the potential labor force to stay away from the fields.

Labor saving devices being introduced into the area (such as the small combine harvester above) need to be evaluated and simple performance reports made readily available.

Conclusion: There is a need for a speedy assessment of the performance of the various combines in terms of harvesting efficiency and machine reliability. When the brief summary report is ready, then this information should be made available through the Cyber extension centers.
